# Manhole Inspection Summary

Manhole # S49CC\_036MH

Insp Date: **2/14/08 11:57 AM**

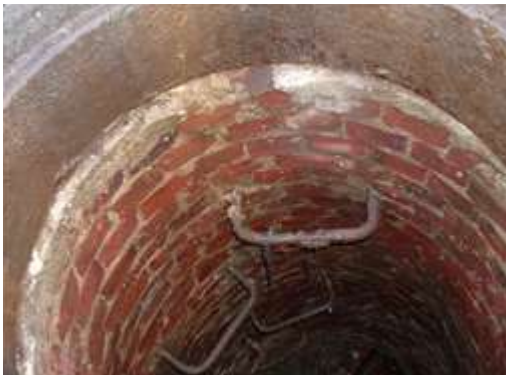
Defect 2

frame leaks

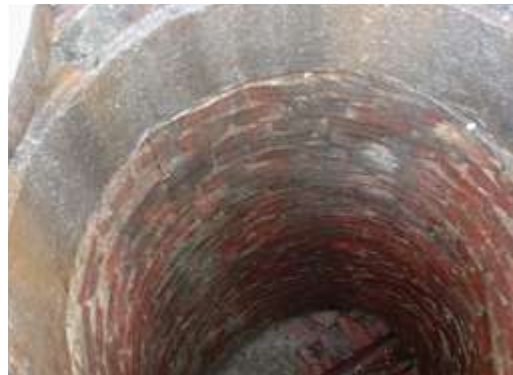
Defect 1

Infiltration: ☐ None ☒ **Joint** ☐ Cracks ☐ Mortar ☐ Roots ☐ Wall

adjustment joint

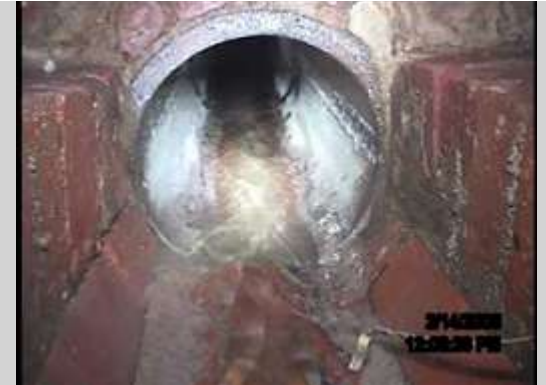
12 O'Clock Outflow

8 in. Circular Gravity Sewer  
Pipe Out @ 12 O'Clock

Pipe Height: **8.4** (in.) Rod and Bar (Angled)  
Pipe Material: **Clay** ☐ Pipe Lined  
Invert Depth: **9.60** (ft.) Flow Characteristics: **Fast**  
Deposits: ☒ None ☐ Mud ☐ Sludge ☐ Debris ☐ Grease  
Silt Depth: (in.) Deposits Extent:  
Infiltration: **None** Pipe Seal Cond: **Sound**

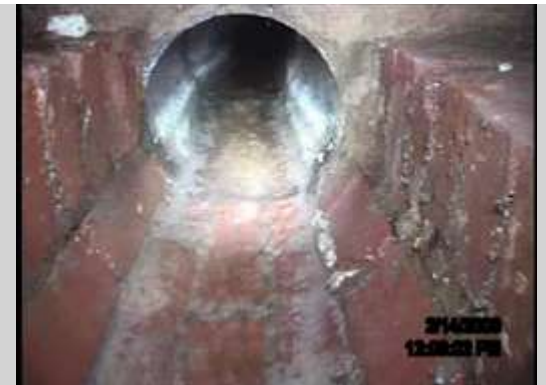
6 O'Clock Inflow

8 in. Circular Gravity Sewer  
Pipe In @ 6 O'Clock

Pipe Height: **8.4** (in.) Rod and Bar (Angled)  
Pipe Material: **Clay** ☐ Pipe Lined  
Invert Depth: **9.55** (ft.) Flow Characteristics: **Fast**  
Deposits: ☒ None ☐ Mud ☐ Sludge ☐ Debris ☐ Grease  
Silt Depth: (in.) Deposits Extent:  
Infiltration: **None** Pipe Seal Cond: **Sound**
